FLEXMAR® Application Focus

FLEXMAR Polyaspartic Coatings Solve Durability, Maintenance Issues on VCT Tile in Dental Office

Zemencik Family Dental

FLEXMAR® Vinyl Chip Polyaspartic Coating System

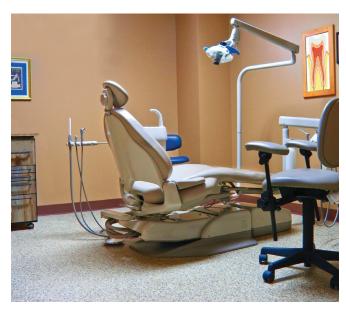
The FLEXMAR polyaspartic coating was applied directly to the existing VCT flooring, reducing overall application time and labor costs.

Once dental equipment was removed from the operatories, the FLEXMAR application crew prepared the floor surface to accept the polyaspartic coating. Normally, FLEXMAR polyaspartic floor coatings are applied to properly prepared concrete. But in this case, the polyaspartic base coat was applied directly to the properly

prepared vinyl tile flooring. The VCT tiles were all intact, well bonded, without curled edges, so there was no need to remove the tiles and adhesive, reducing the overall application time and labor costs.

After the floor prep was complete, a pigmented FLEXMAR polyaspartic base coat was applied and colored vinyl chips were immediately broadcast into the still-wet coating. About an hour later, the base coat was dry, and the excess vinyl chips were removed. Then an initial coat of FLEXMAR clear polyaspartic sealer was applied to encapsulate the vinyl chips. After that coat was dry (again, in about an hour), a second coat of the FLEXMAR clear polyaspartic sealer was applied to increase the thickness of the coating and "pop" the color. In about an hour after the final coat was applied, the floor was ready to walk on and be returned to service, allowing the paint crews to enter and paint the walls.

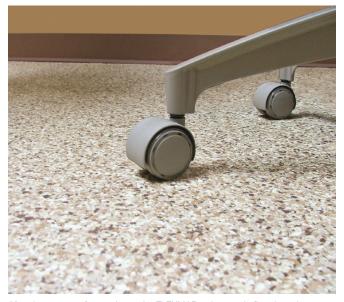
After three years of normal use, the FLEXMAR polyaspartic floor has shown no signs of wear or discoloration.

After three years of normal use, the FLEXMAR polyaspartic floor is holding up just like new, with minimal maintenance. "We're very pleased that we don't need a professional company to come in and strip and clean the floors. Our cleaning regimen is to sweep daily and wet mop with an antibacterial soap weekly. And the shine is still there just like the day that they put it down. In terms of durability, in the three years that the floor's been in place, we are not seeing the wear patterns from the chairs that we saw before."
