Application Focus

FLEXMAR Coatings Beautifies, Protects Concrete Hardware Store Floor at Historic Community Landmark

FLEXMAR® Vinyl Chip Polyaspartic Coating System

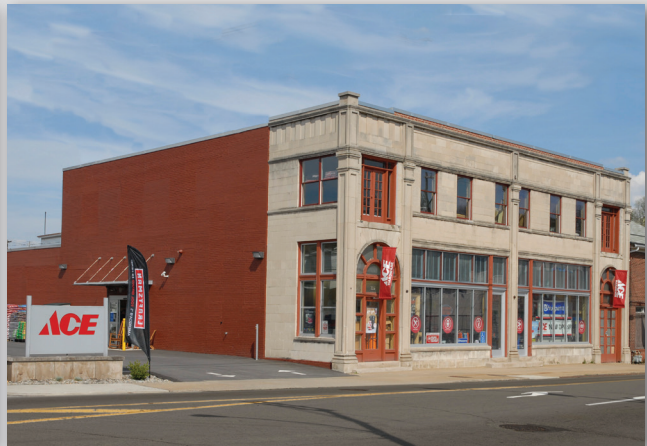
Renovated in 2011, the Ace Hardware in Greensburg, Pennsylvania was designed to elegantly incorporate older elements with modern fixtures.

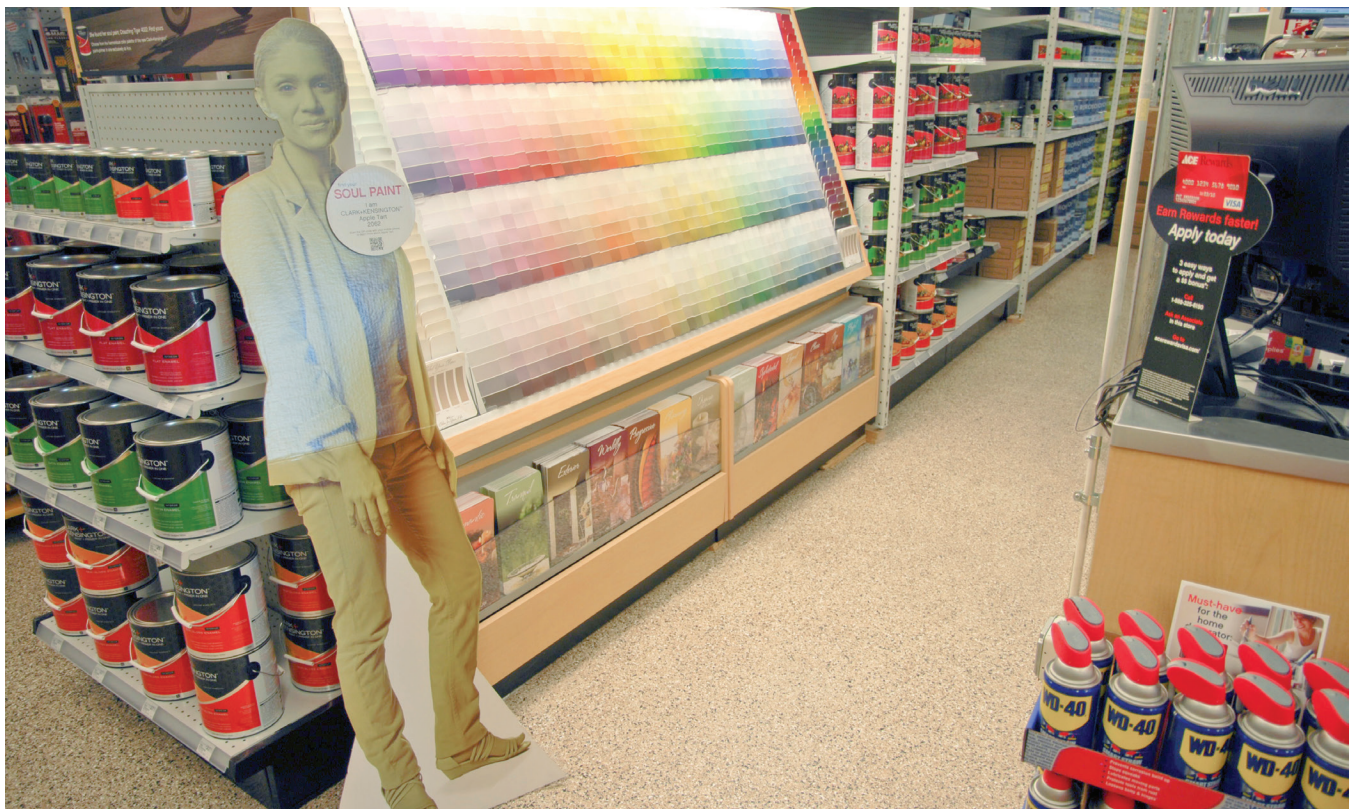
J. Bazella Concrete Construction selected a polyaspartic floor coating system from FLEXMAR Coatings because of FLEXMAR polyaspartics' superior durability and adhesion to concrete. These features were vital considering

the hard use the floor would see and potential for wear and damage, and since not all contaminants could be removed from the concrete prior to application, as recommended.

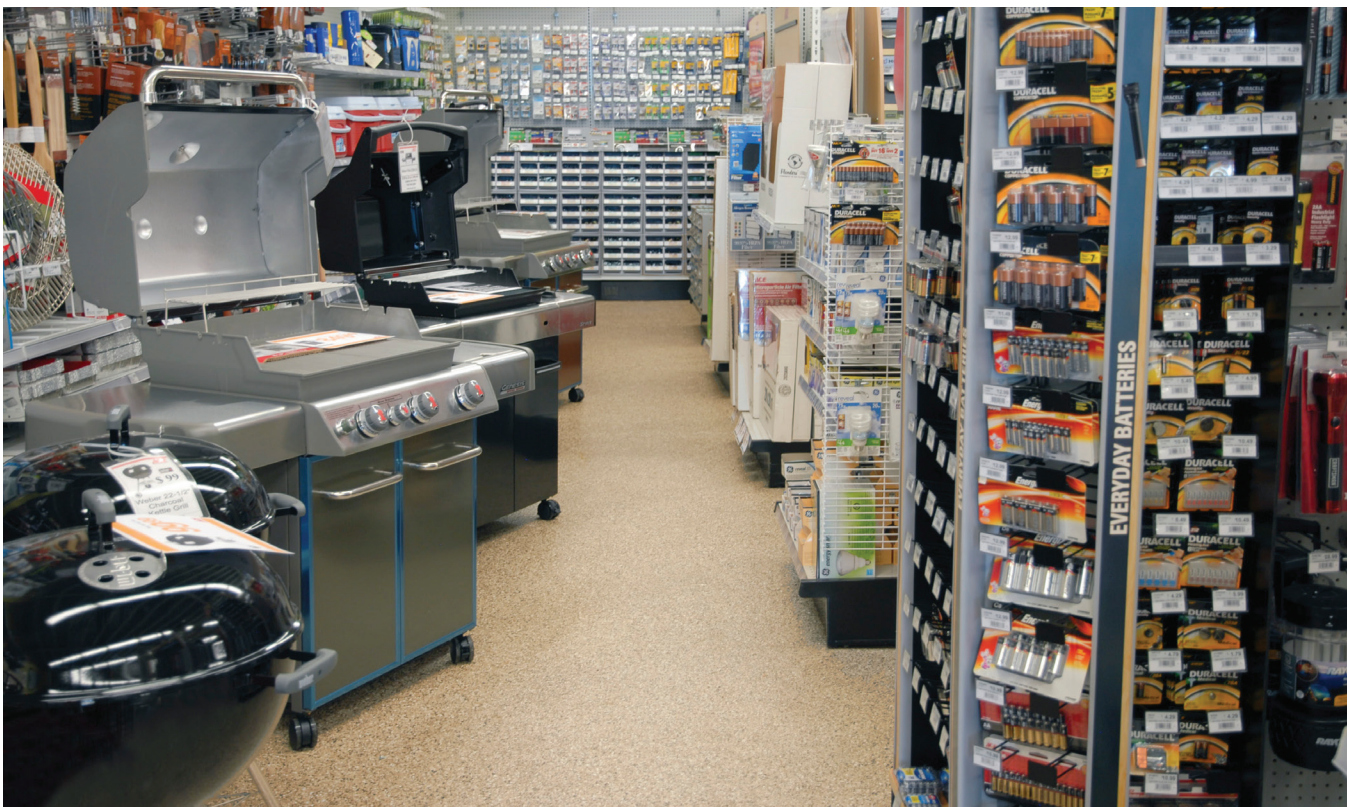
The FLEXMAR vinyl chip polyaspartic floor coating system withstands the abuses it faces on a daily basis . . . and still looks brand new!

The store opened for business in Summer, 2011. Since then, the FLEXMAR vinyl chip polyaspartic floor has stood up to paint, rock salt, and other chemical spills, impacts from falling tools and merchandise, UV light exposure, heavy foot traffic, and machinery traffic. Despite the potential for wear and damage, the floor has continued to look brand new. In fact, the FLEXMAR Clear Coat HS polyaspartic sealer finish coats have given the floor a fresh, glossy look . . . even to this day!

Even more impressively, there are no adhesion or stain problems in the areas where residual oils linger in the concrete. The FLEXMAR Coatings vinyl chip system is holding fast, and the applicator is confident that no problems will arise for the life of the coating.

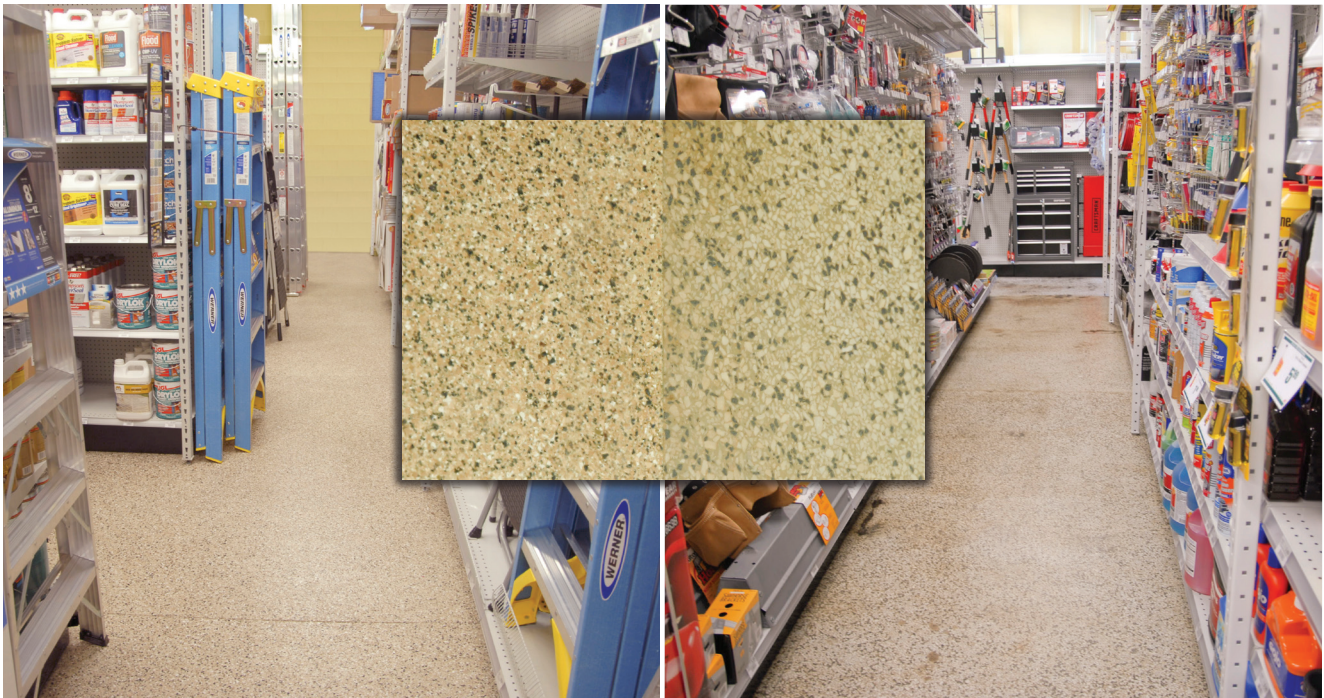
The FLEXMAR vinyl chip polyaspartic floor coating system, left, was chosen to closely match the original terrazzo floor, right, still present in the storefront.

The FLEXMAR floor looks great with minimal attention, but the terrazzo floor requires significantly more maintenance and still shows dirt, grime, and stains.

Perhaps most striking is the difference in appearance and durability between the FLEXMAR polyaspartic floor and the cementitious terrazzo floor in the original storefront area. The FLEXMAR polyaspartic coating has maintained its original color without fading or yellowing and looks great with minimal maintenance. All that's required is a regular dry sweep and wet mop as needed. The terrazzo portion of the floor, however, looks every bit its age, even with routine maintenance. The terrazzo has discolored over time, quickly shows dirt, grime, and

stains, and requires stripping and re-sealing. But even with regular cleaning and re-sealing, the terrazzo floor is not as bright and inviting as the polyaspartic flooring.

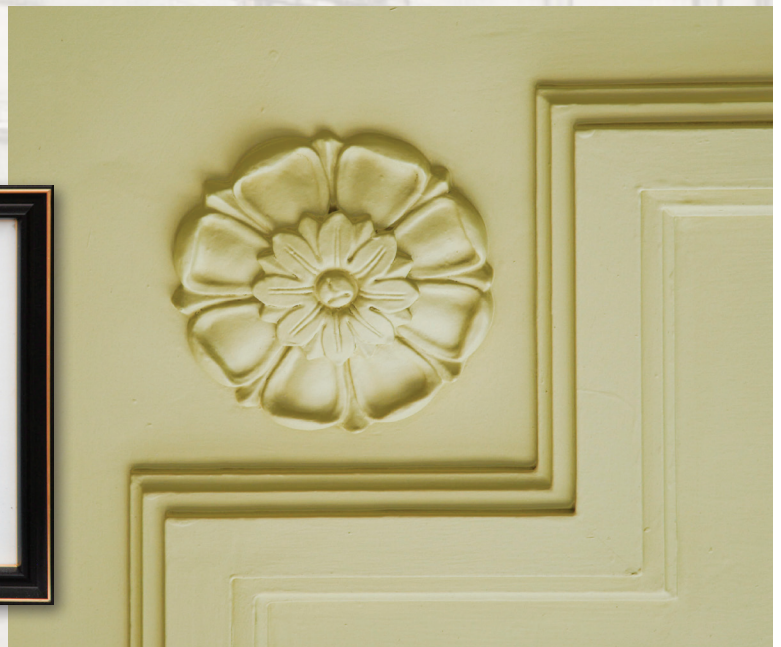
Demolition within the building during the restoration process revealed beautiful details to the interior's architecture.

The prospect and challenge of renewing this building and breathing life back into the downtown lot was exciting for the owner and architect both. As demolition began to the more modern alterations, they discovered ornate ceiling cornices, original plaster beams, and a mainly intact wood storefront.
