# Application Focus

## FLEXMAR Proudly Protects the Concrete Floors of Those Who Protect Our Communities

Ingomar Volunteer  
Fire Company

FLEXMAR® Variegate®  
Polyaspartic Stain-Sealer  
System

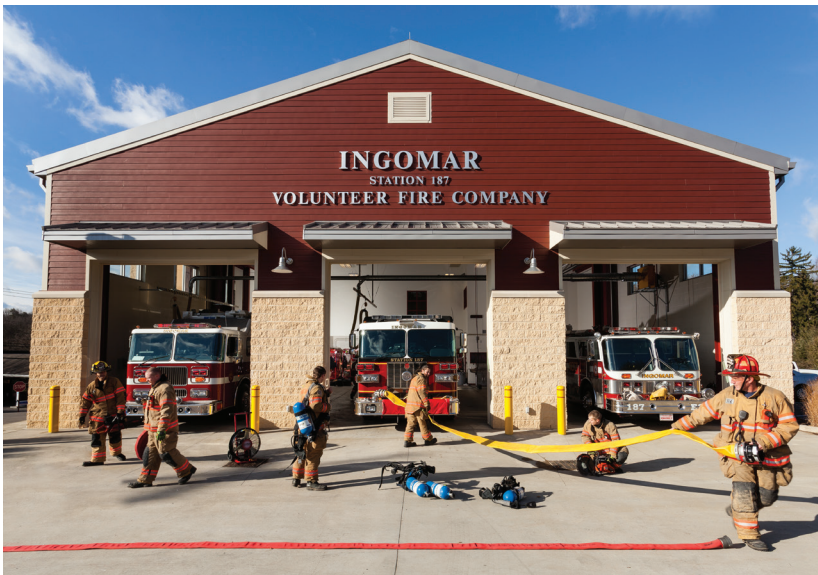
Built in 2012, Ingomar Volunteer Fire Company's main fire station features three apparatus bays with a concrete floor surface totaling 3,600 ft<sup>2</sup>.

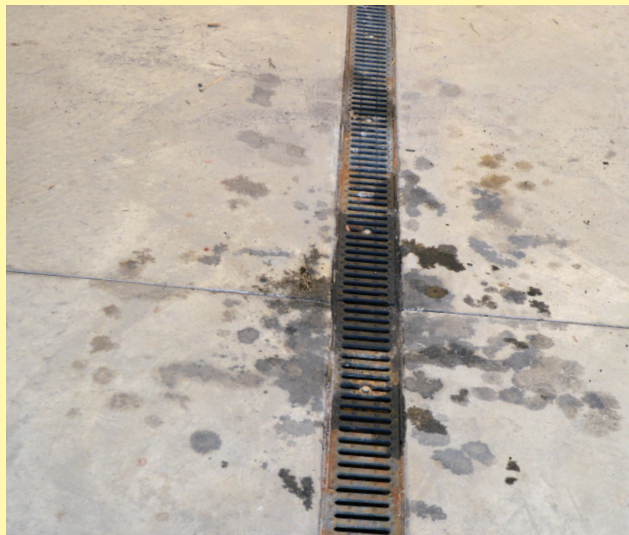
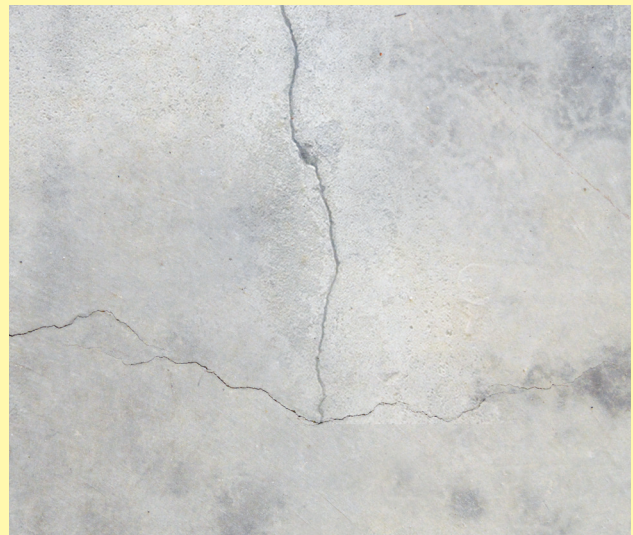
Within a year after being put into service, the bare concrete floor of the apparatus bays was showing cracks and stains and degradation from leaks and spills of caustic, damaging automotive fuels and fluids. Before the polyaspartic coatings could be applied, FLEXMAR-qualified applicators

U-NEEK Concrete Coatings repaired cracks with a polyurea crack repair material and diamond ground the entire surface to remove embedded contaminants and create a profiled surface. The polyaspartic coatings could then be applied directly to the concrete.

The process began with surface preparation. The application crew diamond ground the concrete to remove any contaminants that had been absorbed into the concrete, and to create the optimal surface profile to accept the polyaspartic coating system. Any hairline cracks were repaired as well.

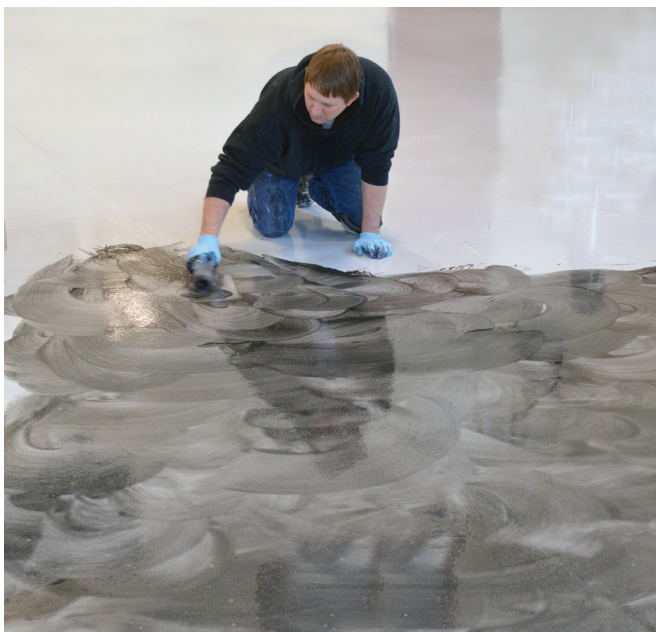
The FLEXMAR-qualified applicators at U-NEEK Concrete Coatings used a combination of a solid-color FLEXMAR polyaspartic coating and semi-transparent FLEXMAR Variegate polyaspartic stain-sealer to create a subtle look that resembled thick black smoke on the floor of the apparatus bays.

Next, a solid-color base coat of White Night Grey FLEXMAR Self-Prime H.S. polyaspartic coating was tightly rolled on the floor surface to seal the concrete and provide an even, light-colored surface. This coat was dry in about an hour and ready for the next coat.

Then, they hand-applied a second coat, an initial coat of Storm Cloud Grey FLEXMAR Variegate polyaspartic stain-sealer. The applicators worked to achieve random strokes with even shading. This coat was dry in about an hour and ready for the next coat.

The third coat, a second coat of Variegate stain-sealer, was hand-applied the same way, darkening the color, adding more depth to the look, and muting individual strokes. An aggressive slip reduction agent was broadcast into this coat while it was still wet. Like the first two coats, this coat was dry in about an hour and ready for the next coat.

The finish coat was a proprietary mixture of Variegate stain-sealer, FLEXMAR Clear Coat H.S. polyaspartic sealer, and the iridescent additive. It was hand-applied like the previous two coats, and more of the slip reduction agent was broadcast into this coat for additional protection against slips and falls. This coat was ready to be walked on in about an hour, and could withstand light traffic later in the evening.

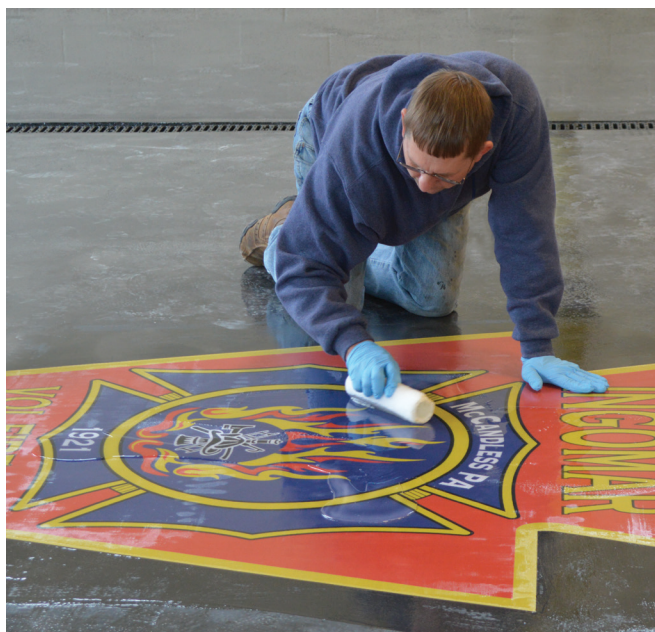
As a finishing touch, two logos, each sixty inches wide, were embedded in a final coat of FLEXMAR clear polyaspartic sealer.

Finishing the appearance of the apparatus bay floor are two large, sixty-inch-wide fire company logos, embedded within a layer of FLEXMAR Clear Coat H.S. polyaspartic sealer. They are located in between each bay, right where firefighters enter and exit the trucks. For the fire company, it's a matter of pride.

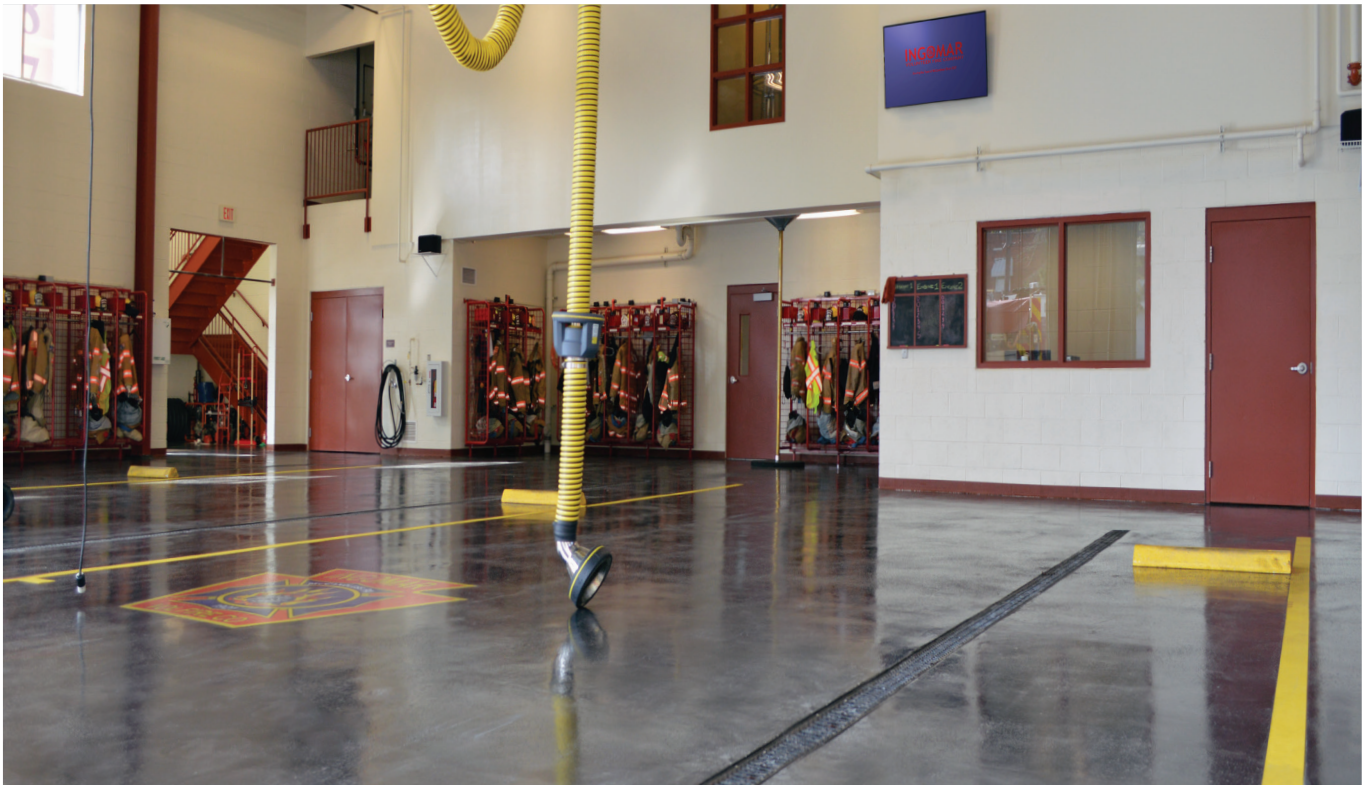
The FLEXMAR Variegate polyaspartic stain-sealer system was applied with minimal disruption to the fire company's normal operation.

The coatings system was applied in stages across the apparatus bays. Each bay was prepped and coated one-at-a-time, allowing firefighters to still access their gear lockers and other portions of the station during the application process. The amount of equipment that had to be moved in preparation for the floor work was kept to a minimum, and the firefighters could keep their focus on their normal day-to-day tasks.
